Smoke and Dye-Water Observation Summary

Western Run Pilot Project - Baltimore Maryland

Dye Test 67

INSPECTION REPORT

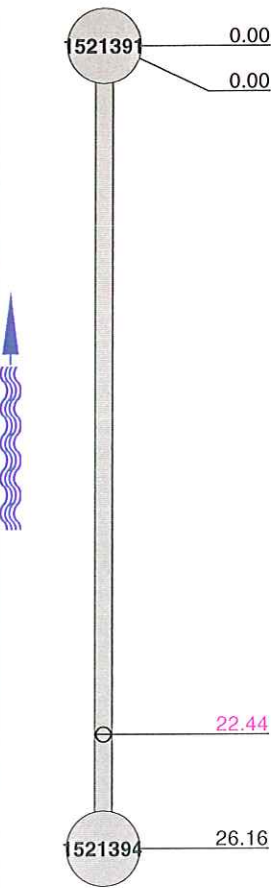
0.00	inspection begins at downstream manhole, 1521391	0	00:11:17	
	0.00	M.H. WALL LEAKING		00:11:57	
	22.44	service connection with infiltration gushing around at 01 o'clock	00:13:44	17a, b	
	26.16	inspection ends, NO MORE DYE TEST LEAKS SEEN.	0	00:14:30	18a
